Problems with solar PV

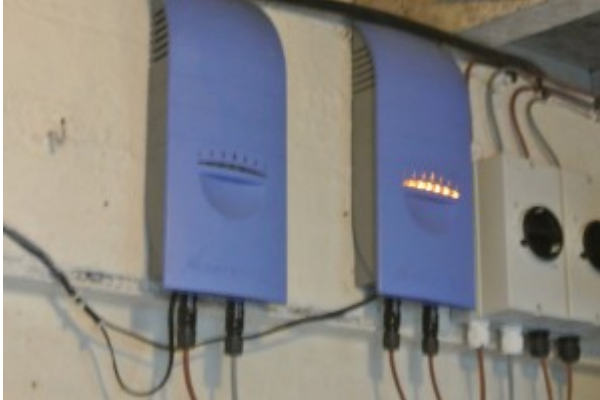
Problems with solar PV are few and far between but I've had a few issues recently. The first is an ongoing problem with grey squirrels nesting under one module on the main roof. Obviously there is an issue with them chewing through the wiring. I have seen them have an experimental try at the DC cables on the newer system (see below). I drove them out but recently they show signs of coming back. This is despite the water that must pour under the module when it rains. The second of my problems with solar PV has been potentially more serious although relatively easy to solve. Last Tuesday when it snowed I realised one of the inverters (4 x 250W, 2 per inverter) was not working.

I found two cables had parted at a connector. I taped over them

with frog tape in the meanwhile getting a shock from the panel side (despite the snow on the module).

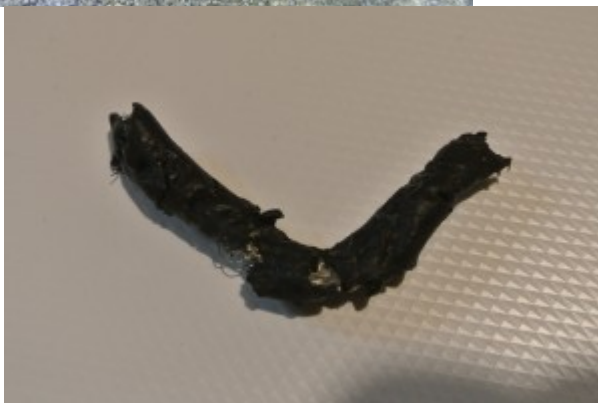
Eventually I discovered the remains of the old connector which

had melted.

This is a minor issue and was easy to solve since I had easy access. This problem on the old system on the main roof would need professional help and hence the need to keep the squirrels at bay (with chickenwire). The reasons for the arcing? Probably the connector had not been installed properly 6 years ago (the supplier of the connectors thought). Its amazing what you can get away with though with no damage to the rest of the system. A last thought. If this had happened in the loft though we would have had a fire. Neil

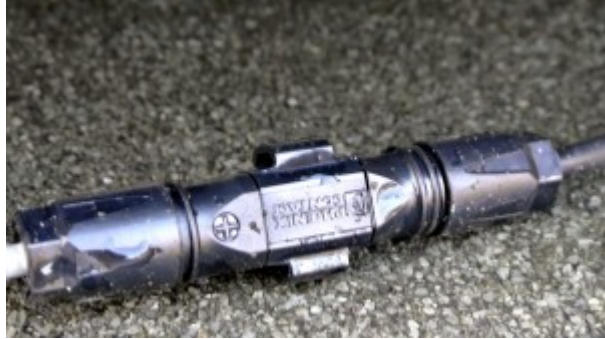
installers/dealers have closed including the company that installed the system (apparently). There is a company that sells systems and system components that I know about that has been around for many years. I rang them and ordered the connectors. In the meanwhile I covered the module concerned to stop any output and reduce the chances of arcing. When the connectors arrived they were difficult to fit. No instructions came with them nor could I find any on the net. I covered the two modules up and had a go but could not get the connectors together. After several phonecalls to the supplier (who were very helpful) and looking a video on youtube I went back after dark and had more success. Would

everything work OK. The next morning revealed yes it would.
